**Flood Control Project Maintenance
Levee Inspections**
LMA District Cover Sheet
Spring 2020 Levee Inspection Results

Sacramento Maintenance Yard Willow Slough Bypass

Spring 2020 Levee Inspection Results

Waterway			Bank	Unit Miles
Unit No. 01 Willow Slough Bypass or North Levee			Left	5.05
	Spring (March - May)	Summer (June - August)	(September - November) Fall	Winter (December - February)
Unit Maintenance Rating (Fall Only)				
Date of Inspection	4/7/2020 - 4/7/2020			
DWR Inspector	Zach Jojola			
Accompanied By

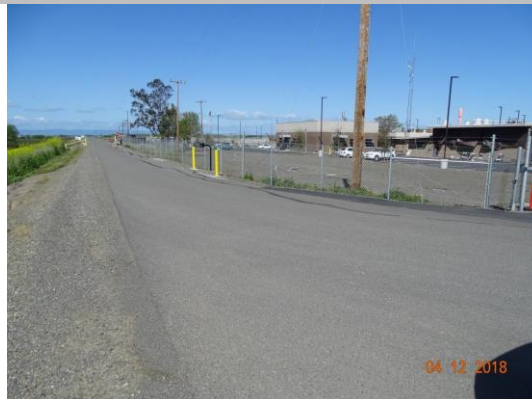
Photo 1 of 1 : SP_2020_ST0012_295_17_20200228_00006.jpg

View of fence on the landside shoulder. Spring 2018.

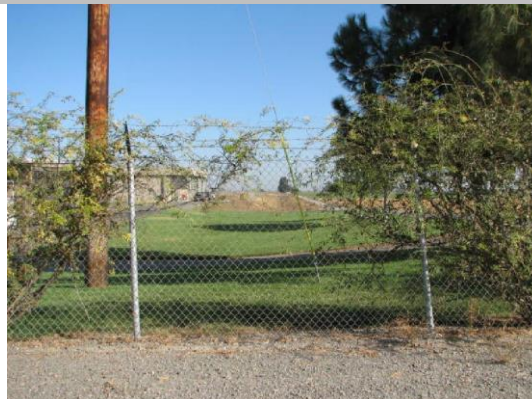
Photo 1 of 3 : UCIP_SP_2020_44903_22882.jpg

Landside view- beyond grass area see drainage inlet

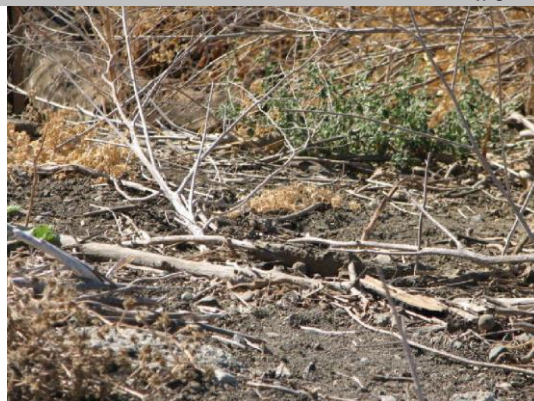
Photo 2 of 3 : UCIP_SP_2020_44903_22881.jpg

Waterside view- general view

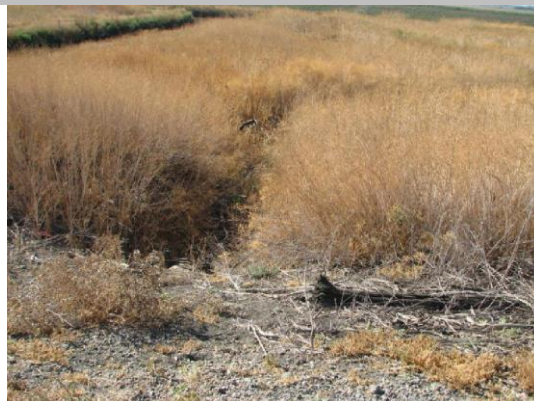
Photo 3 of 3 : UCIP_SP_2020_44903_22880.jpg

Waterside overview. Notice waterway.

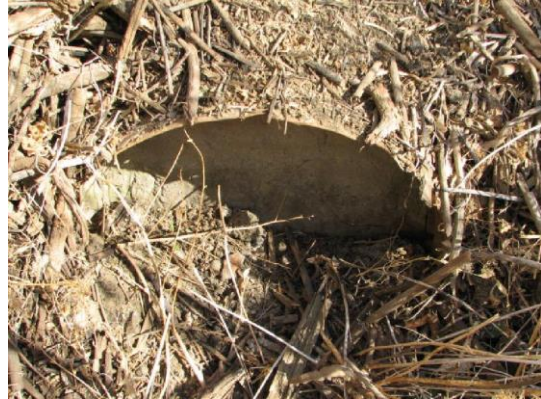
Photo 1 of 3 : UCIP_SP_2020_44904_22885.jpg

Waterside view- CMP grouted with concrete.

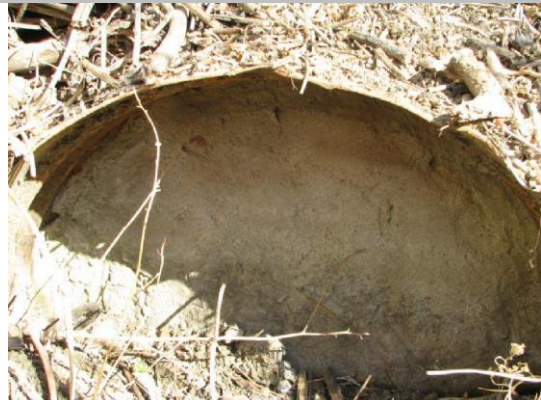
Photo 2 of 3 : UCIP_SP_2020_44904_22884.jpg

Waterside view- CMP grouted with concrete (closer view)

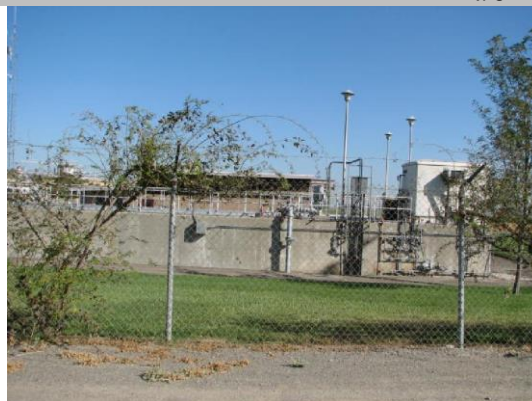
Photo 3 of 3 : UCIP_SP_2020_44904_22886.jpg

Landside overview- pumping plant not related with this crossing.

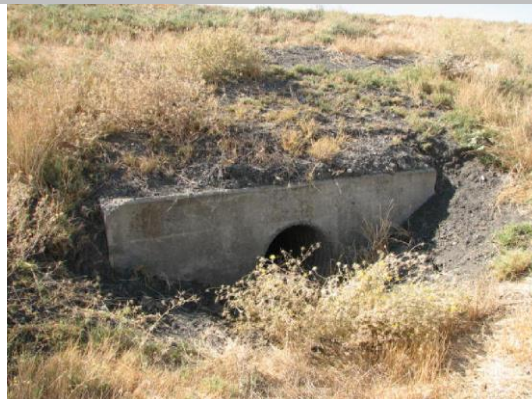
Photo 1 of 3 : UCIP_SP_2020_44907_22894.jpg

Landside view- pipe and headwall

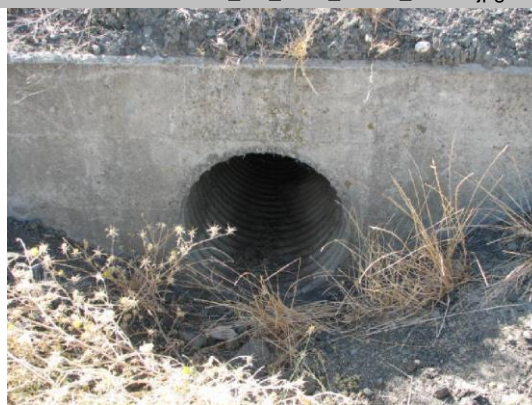
Photo 2 of 3 : UCIP_SP_2020_44907_22893.jpg

Landside view- pipe and headwall closer view

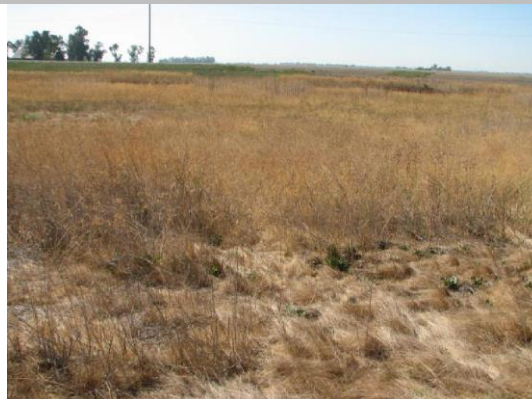
Photo 3 of 3 : UCIP_SP_2020_44907_22892.jpg

Waterside view

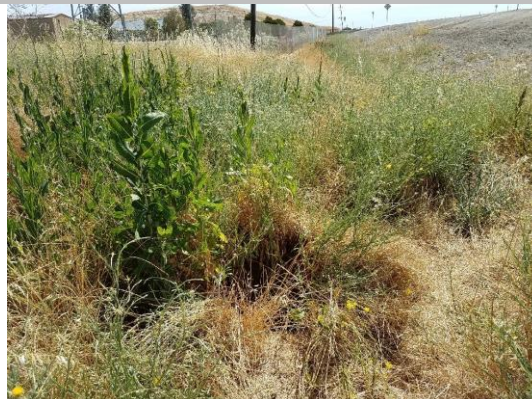
Photo 1 of 3 : UCIP_SP_2020_54247_80003.jpg

Landside view

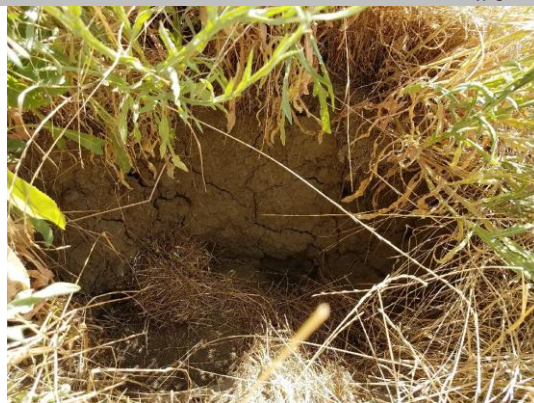
Photo 2 of 3 : UCIP_SP_2020_54247_80001.jpg

Comment Code						
Inspector Comment						
DS_ID:17612 FS_ID:54247 EP_NO: 10315 Repair Type: Non-Urgent Crossing Status: Found UCIP Comments07/01/2019 Crossing has been modified from irrigation siphon to storm drainage prior to 2012. No permit has been found authorizing the modifications to this pipe. Pipe inlet on LS is buried in soil. Sinkhole approximately 2-foot in diameter and 2-foot deep located at LS toe along pipe alignment. This crossing was internally inspected as part of the DWR's Deferred Maintenance Project in 2017. Unable to determine what happened to the pipe section through the channel and opposite levee. Coordinating with LMA and Yolo County to determine owner of crossing. (O.Yakimov - DWR UCIP) 09/19/2012 Looks 24-inch HDPE pipe sleeved through 42-inch pipe. A 30-inch flap gate on WS looks recently replaced. (DWR UCIP - P. Amatya) FIELD_STRUCT_DESC: 24-inch drainage pipe sleeved through an existing 42-inch siphon steel irrigation pipe through the levee, 13.5 feet below the crown. 42-inch pipe cut off and steel plate welded at WS toe, annular space seems to be filled with cement slurry. Pipe inlet enclosed into concrete casing on the landside (LS) end. (42-inch pipe authorized under Automatic Board Order (ABO) issued as Permit No. 10315, 1974 - Reclamation District No. 2035) [Additional Reference(s): DWR Levee Log, 1990. USACE Sacramento O&M Manual Unit 120, Willow Slough Channel Relocation and Levee Construction, February 1947, Drawing No. 50-4-2281 Sheet 2 (Station 193+70)] FS Date: 7/1/2019 3:27:02 PM

Closeup view of sinkhole

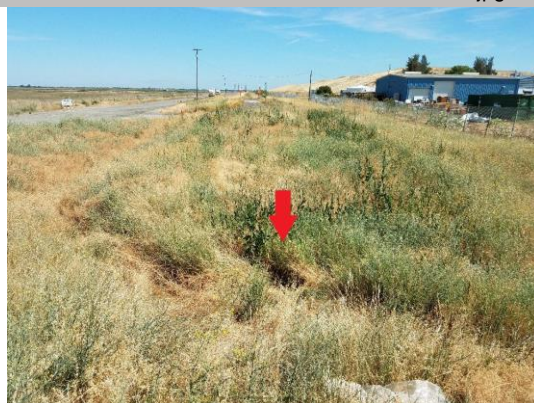
Photo 3 of 3 : UCIP_SP_2020_54247_80002.jpg

Sinkhole at LS toe at pipe alignment

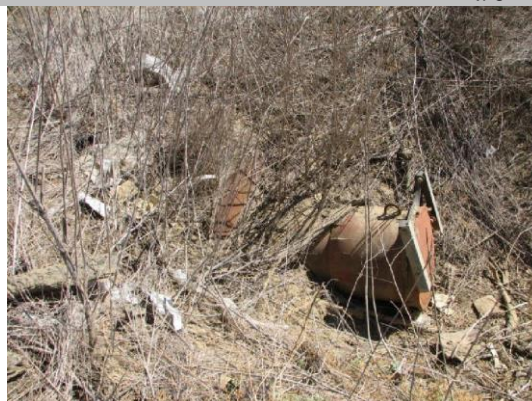
Photo 1 of 3 : UCIP_SP_2020_44929_22929.jpg

Waterside view- pipe and flap gate

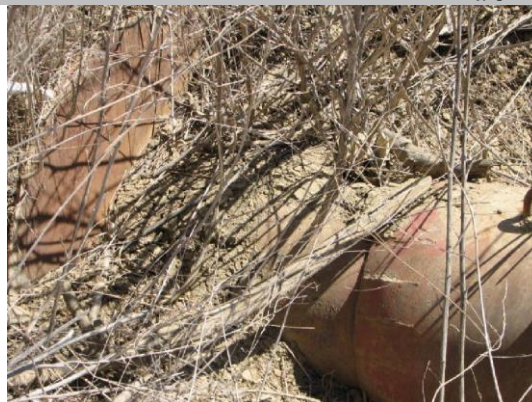
Photo 2 of 3 : UCIP_SP_2020_44929_22928.jpg

Waterside view- 20-inch pipe sleeved into 30-inch pipe

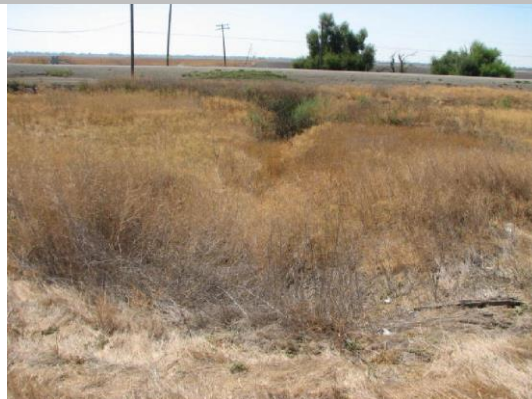
Photo 3 of 3 : UCIP_SP_2020_44929_22931.jpg

Waterside overview

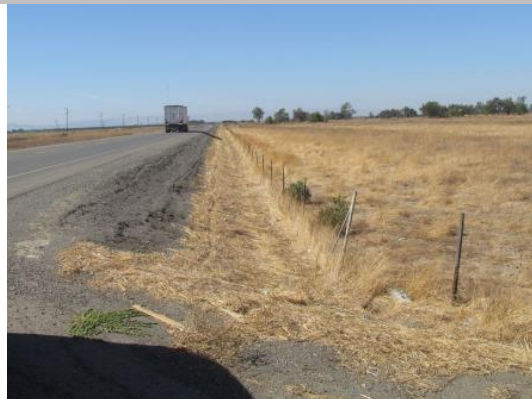
Photo 1 of 1 : SP_2020_ST0012_295_14_20200228_00005.jpg

LM Start	1.53	Rating **	M	Issue No.	14
LM End	2.20	Issue Type +	En	Location *	LS
Category	Earthen Levee			GPS Latitude/Longitude	
				Start	End
Item	Encroachments			38.590334 °	38.590466 °
				-121.693618 °	-121.705849 °
DWR ID	DWR_ST0012_01_f_2016_14				
Comment Code					
FE : Fence					
Inspector Comment					
There is a barbed wire fence along this section of levee.

View of fence encroaching 10-foot easement on landward side of the levee. Fall 2016.

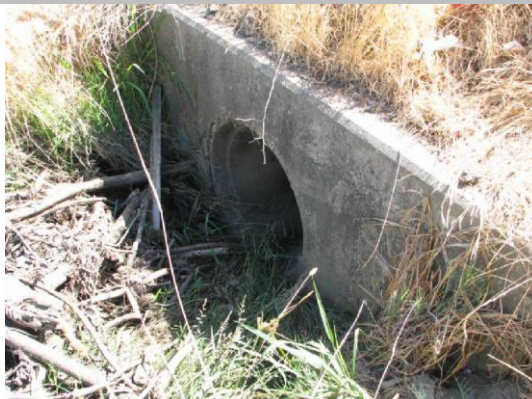
Photo 1 of 3 : UCIP_SP_2020_44937_22951.jpg

Landside view- concrete pipe and headwall.

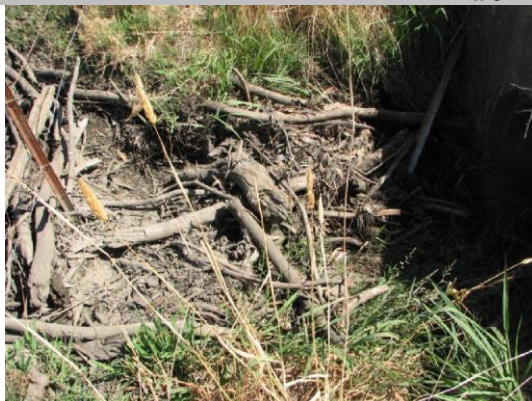
Photo 2 of 3 : UCIP_SP_2020_44937_22949.jpg

Landside view- debris

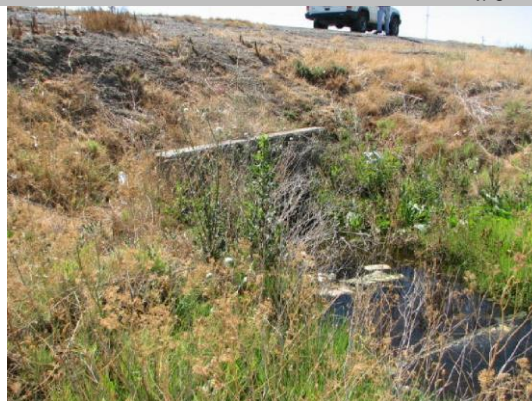
Photo 1 of 3 : UCIP_SP_2020_55422_22962.jpg

Landside view- inlet structure

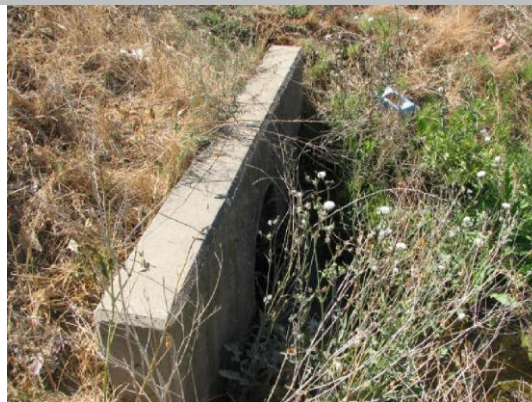
Photo 2 of 3 : UCIP_SP_2020_55422_22961.jpg

Landside view- concrete headwall

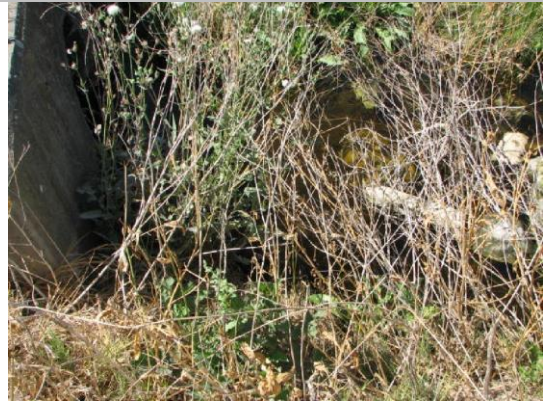
Photo 3 of 3 : UCIP_SP_2020_55422_22960.jpg

Landside view- vegetation around inlet.

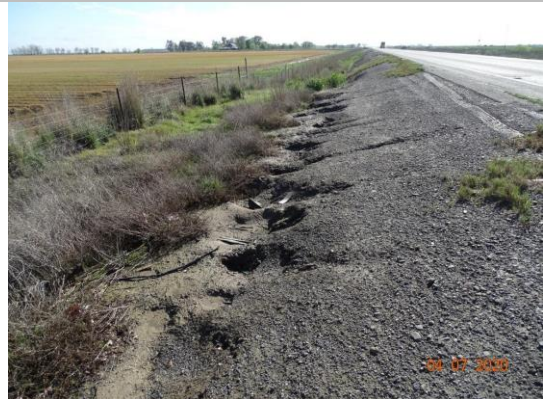
Photo 1 of 1 : SP_2020_ST0012_295_10_20200409_00036.jpg

LM Start	2.93	Rating **	M	Issue No.	10
LM End	3.00	Issue Type +	Ma	Location *	LS
Category	Earthen Levee			GPS Latitude/Longitude	
				Start	End
Item	Erosion / Bank Caving			38.590572 °	38.590653 °
				-121.719349 °	-121.720714 °
DWR ID	DWR_ST0012_01_s_2015_10				
Comment Code					
E1 : Note and monitor erosion site.					
Inspector Comment					
There appears to be runoff on the landside slope.

View of erosion on the landside slope. Spring 2020.

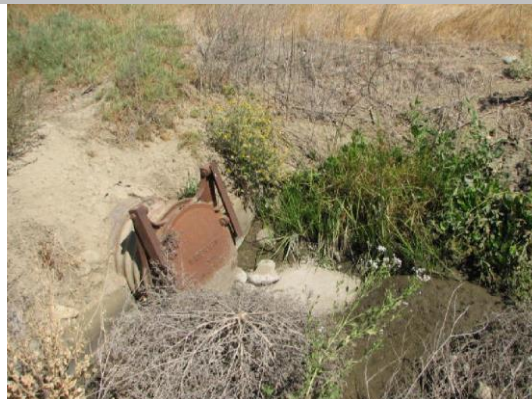
Photo 1 of 3 : UCIP_SP_2020_55421_22967.jpg

Waterside view- pipe and flap gate.

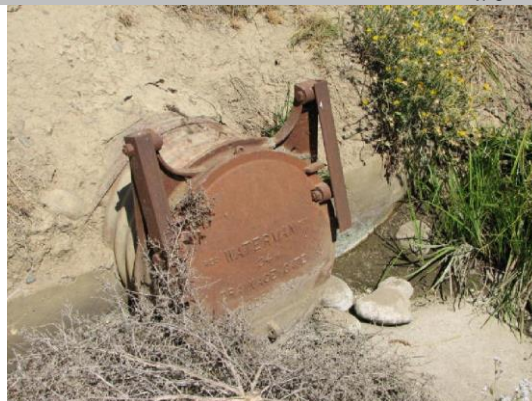
Photo 2 of 3 : UCIP_SP_2020_55421_22970.jpg

Waterside view- pipe and flap gate (close view).

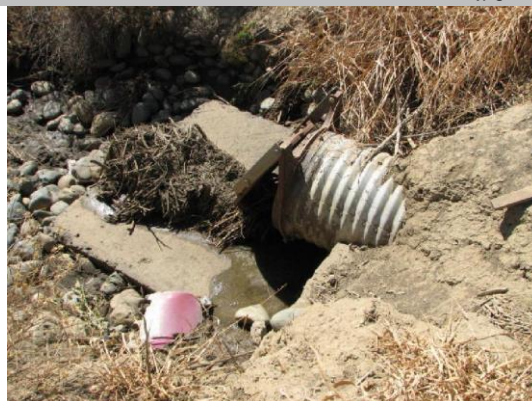
Photo 2 of 3 : UCIP_SP_2020_44947_22983.jpg

Waterside view- pipe, flap gate and debris.

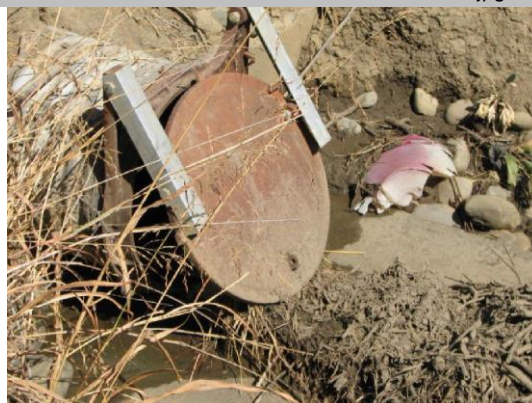
Photo 3 of 3 : UCIP_SP_2020_44947_22986.jpg

Waterside view- pipe, flap gate and debris. The pipe sits on concrete saddle.

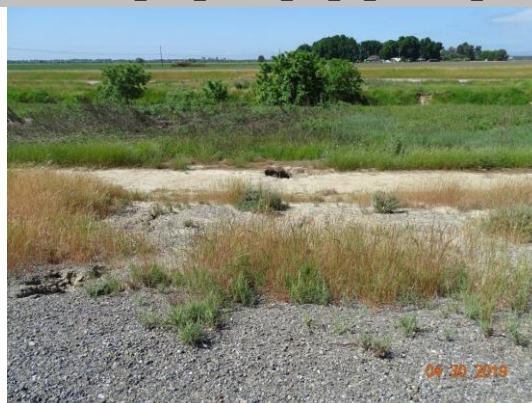
Photo 1 of 1 : SP_2020_ST0012_295_23_20200228_00008.jpg

LM Start	3.69	Rating **	M	Issue No.	23
LM End	3.69	Issue Type +	Ma	Location *	WS
Category	Earthen Levee			GPS Latitude/Longitude	
				Start	End
Item	Erosion / Bank Caving			38.591699 °	38.591699 °
				-121.733066 °	-121.733066 °
DWR ID	DWR_ST0012_01_s _ 2019_23				
Comment Code					
E2 : Schedule repair of erosion site prior to the next inspection.					
Inspector Comment					
Appears to be runoff erosion on the waterside slope and toe road.

View of hole on the toe road. Spring 2019.

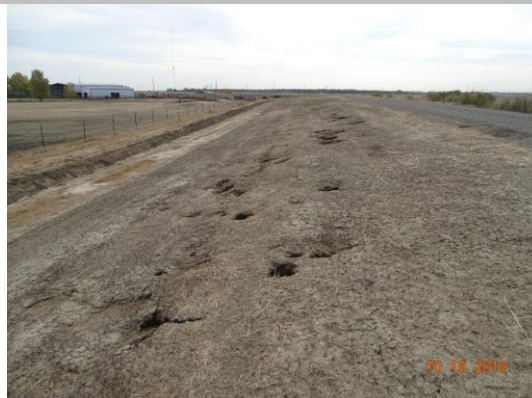
Photo 1 of 1 : SP_2020_ST0012_295_20_20200228_00007.jpg

LM Start	3.88	Rating **	M	Issue No.	20
LM End	3.92	Issue Type +	Ma	Location *	LS
Category	Earthen Levee			GPS Latitude/Longitude	
				Start	End
Item	Slope Stability			38.593886 °	38.594355 °
				-121.734986 °	-121.735409 °
DWR ID	DWR_ST0012_01_f_2019_20				
Comment Code					
S1 : Repair slope instability.					
Inspector Comment					
Appears to be many sinkholes on the landside slope.

View of sinkholes on the landside slope. Fall 2019.

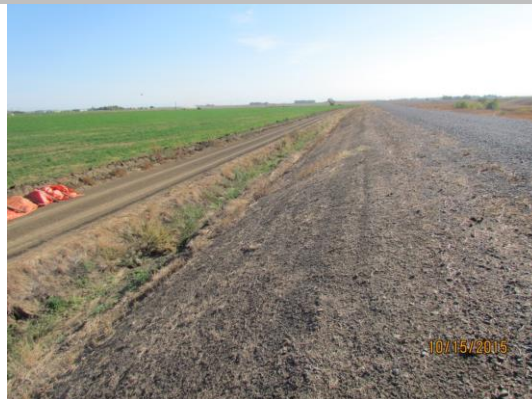
Photo 1 of 1 : SP_2020_ST0012_295_4_20200228_00001.jpg

View of the ditch on the landward side of the levee looking downstream.
Fall 2015.

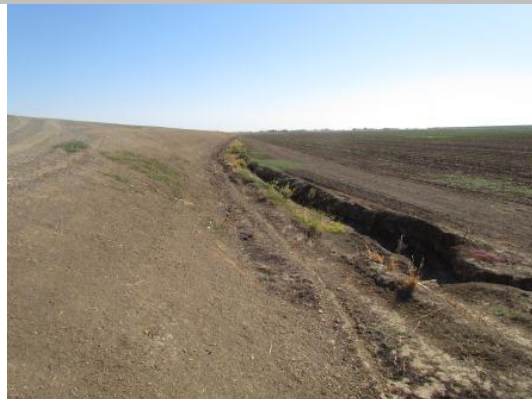
Photo 1 of 1 : SP_2020_ST0012_296_7_20200228_00001.jpg

A view of the ditch near LM 0.29. Fall 2016.

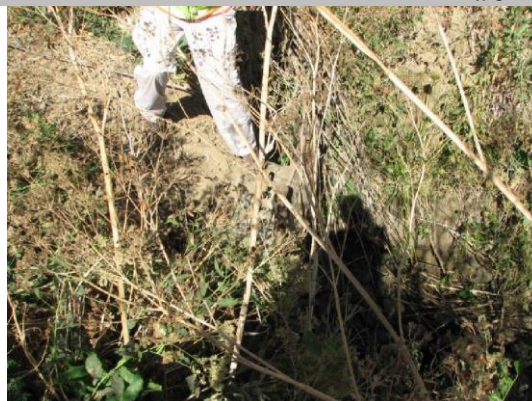
Photo 1 of 3 : UCIP_SP_2020_45286_22464.jpg

Waterside view- concrete headwall and CM pipe

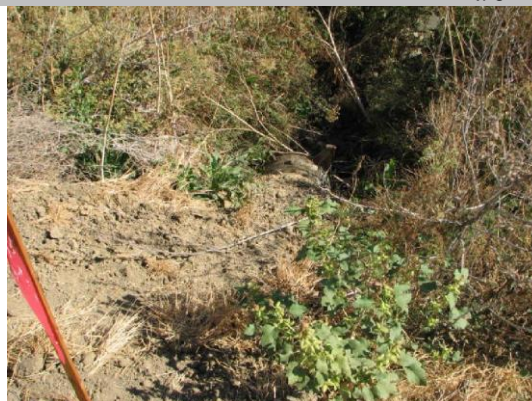
Photo 2 of 3 : UCIP_SP_2020_45286_22460.jpg

Waterside view- overview

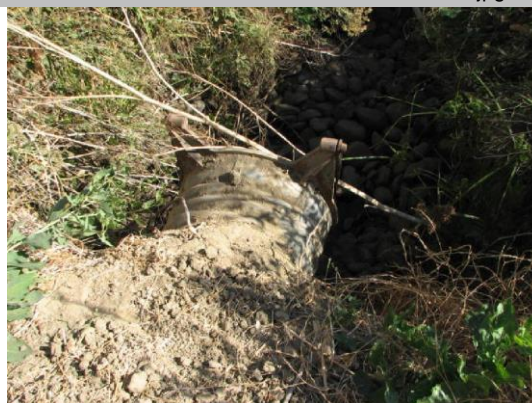
Photo 3 of 3 : UCIP_SP_2020_45286_22461.jpg

Waterside view- CM pipe and flap gate.

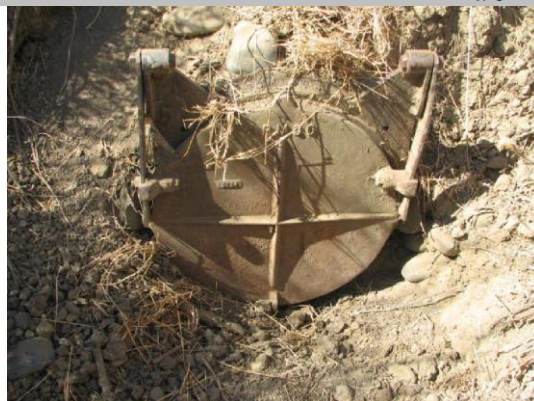
Photo 1 of 3 : UCIP_SP_2020_13725_22470.jpg

Waterside view- flap gate and CM pipe

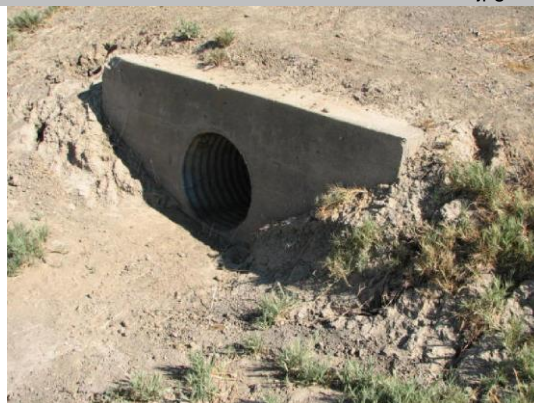
Photo 2 of 3 : UCIP_SP_2020_13725_22469.jpg

Landside view- concrete headwall and pipe

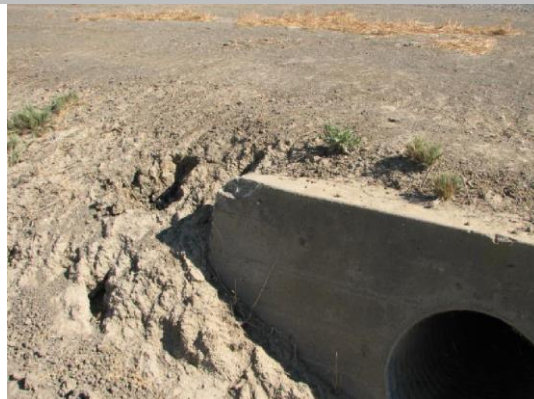
Photo 3 of 3 : UCIP_SP_2020_13725_22468.jpg

Landside view- concrete headwall corner chipped off

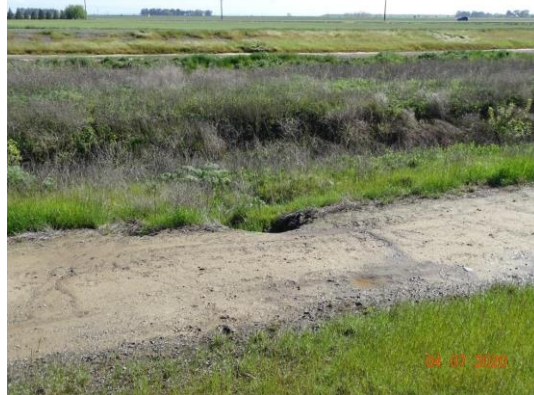
Photo 1 of 1 : SP_2020_ST0012_296_24_20200409_00050.jpg

View of erosion within the waterside toe road. Spring 2020.

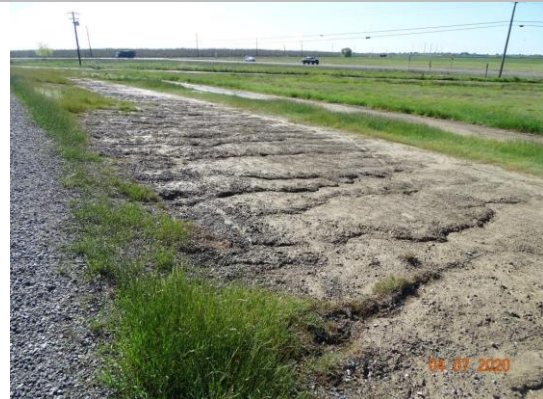
Photo 1 of 1 : SP_2020_ST0012_296_29_20200409_00049.jpg

View of rills on the landside slope. Spring 2020.

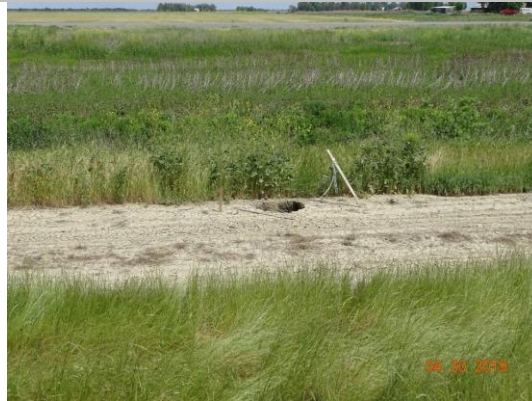
Photo 1 of 1 : SP_2020_ST0012_296_28_20200228_00007.jpg

View of erosion on the waterside toe road. Spring 2019.

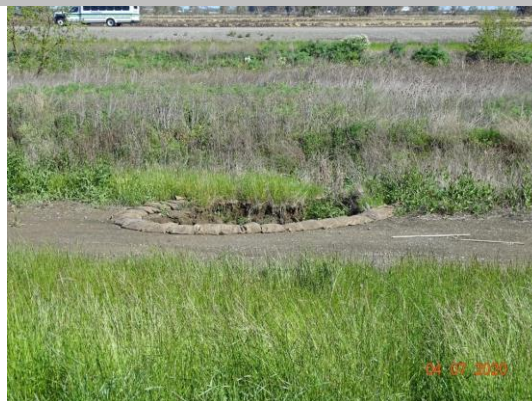
Photo 1 of 1 : SP_2020_ST0012_296_19_20200409_00051.jpg

View of erosion on waterside toe road. Spring 2020.

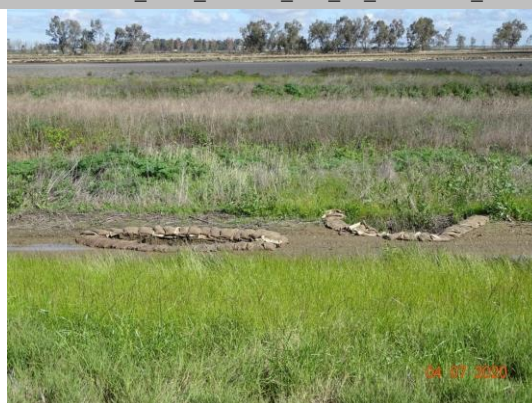
Photo 1 of 1 : SP_2020_ST0012_296_10_20200409_00052.jpg

View of erosion on waterside toe road. Spring 2020.

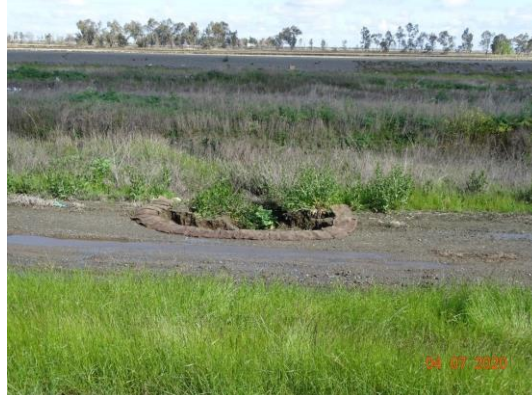
Photo 1 of 1 : SP_2020_ST0012_296_30_20200409_00053.jpg

View of erosion within the waterside toe road. Spring 2020.

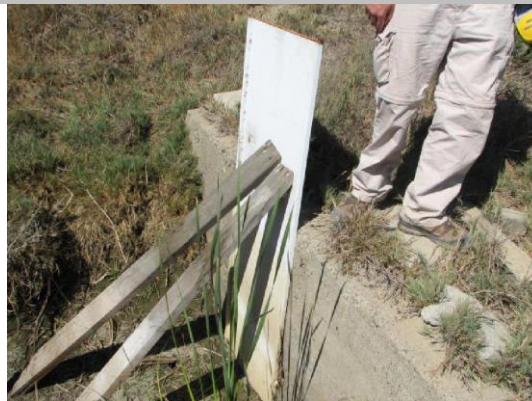
Photo 1 of 3 : UCIP_SP_2020_45291_22479.jpg

Landside view- concrete headwall and pipe (temporarily closed used wooden planks).

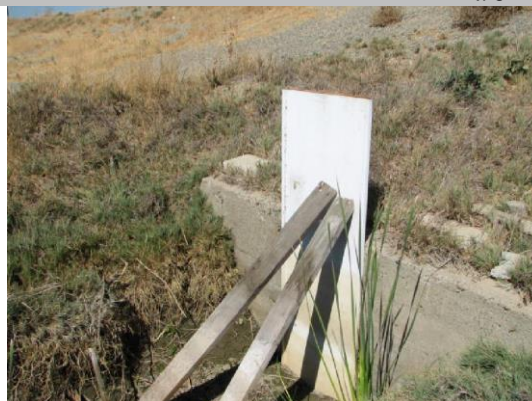
Photo 2 of 3 : UCIP_SP_2020_45291_22478.jpg

Landside view- concrete headwall

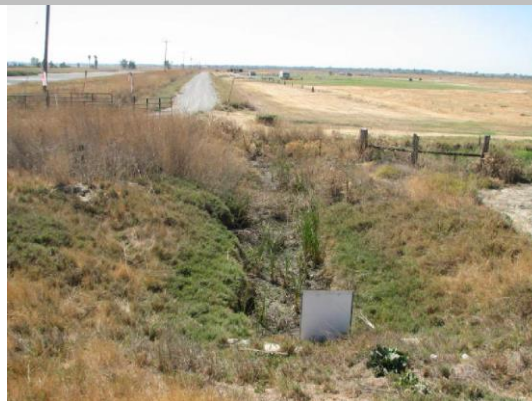
Photo 3 of 3 : UCIP_SP_2020_45291_22477.jpg

Landside view- open ditch.

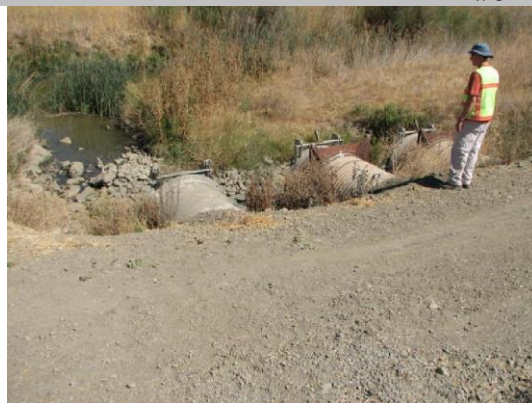
Photo 1 of 3 : UCIP_SP_2020_45294_22789.jpg

Waterside overview- middle 42-inch pipe.

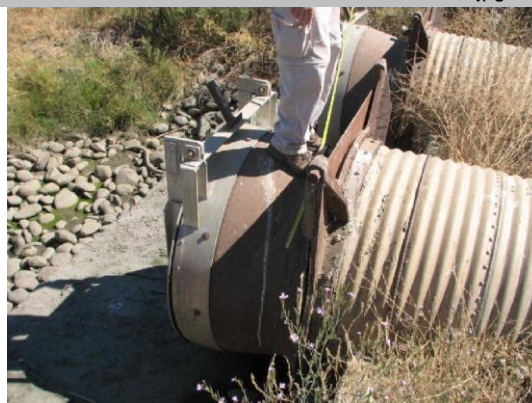
Photo 3 of 3 : UCIP_SP_2020_45294_22792.jpg

Waterside view- 42-inch steel pipe and flap gate.

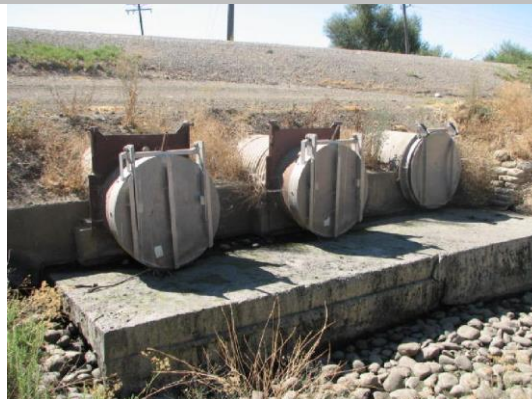
Photo 3 of 3 : UCIP_SP_2020_45295_22796.jpg

Waterside overview- outlet structure.

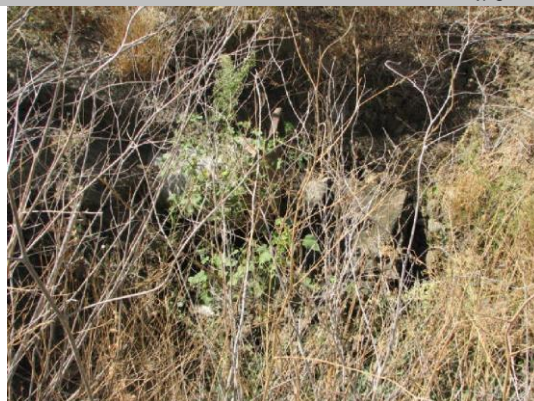
Photo 1 of 3 : UCIP_SP_2020_45298_22805.jpg

Waterside overview- pipe and flap gate with dense vegetation.

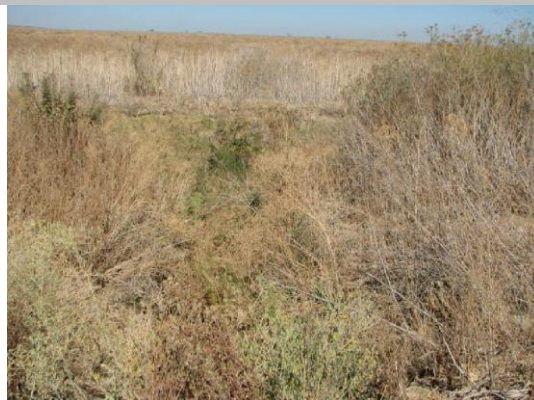
Photo 2 of 3 : UCIP_SP_2020_45298_22804.jpg

Landside overview

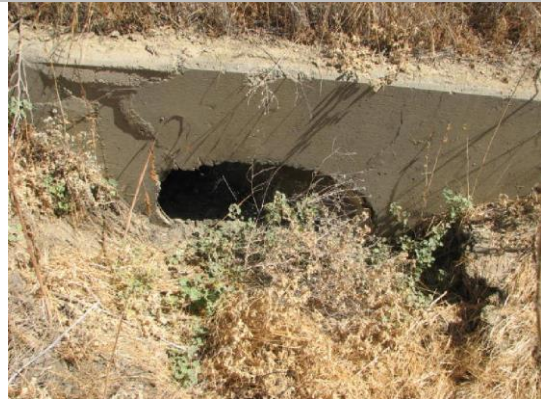
Photo 2 of 3 : UCIP_SP_2020_45285_22811.jpg

Landside view- pipe and headwall.

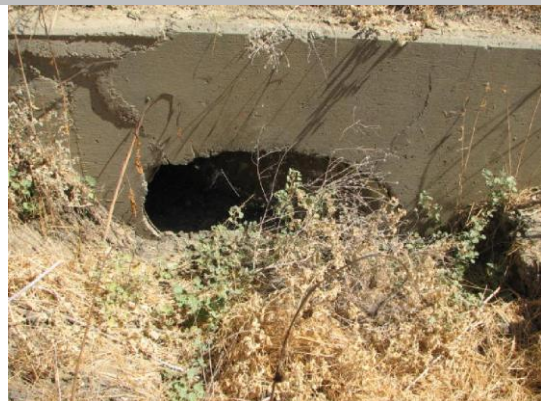
Photo 3 of 3 : UCIP_SP_2020_45285_22810.jpg

Landside view- soil and debris on mouth of the inlet pipe.

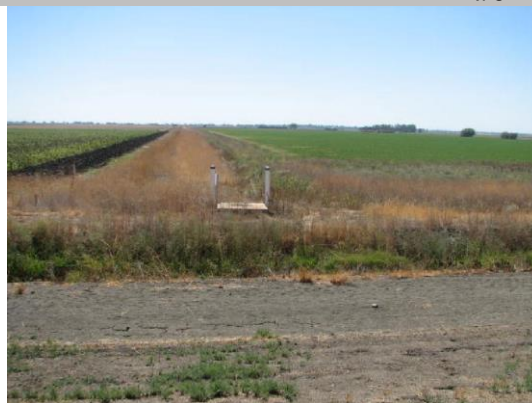
Photo 1 of 3 : UCIP_SP_2020_45301_22845.jpg

Landside view- overview

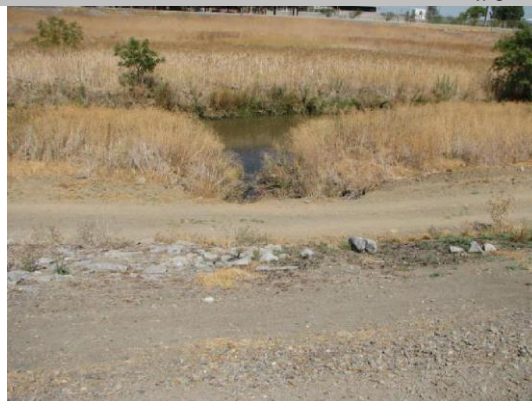
Photo 2 of 3 : UCIP_SP_2020_45301_22844.jpg

Waterside view- overview

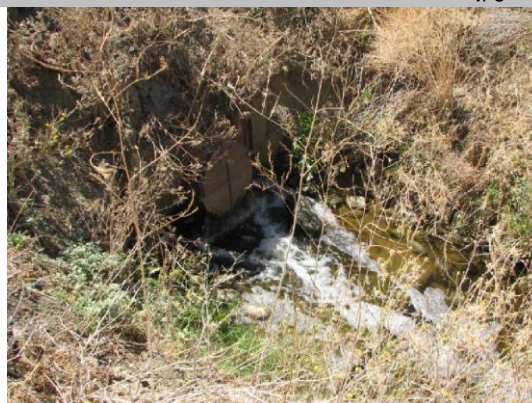
Photo 3 of 3 : UCIP_SP_2020_45301_22846.jpg

Waterside view- pipe and flap gate. Water was running in the pipe during the survey.

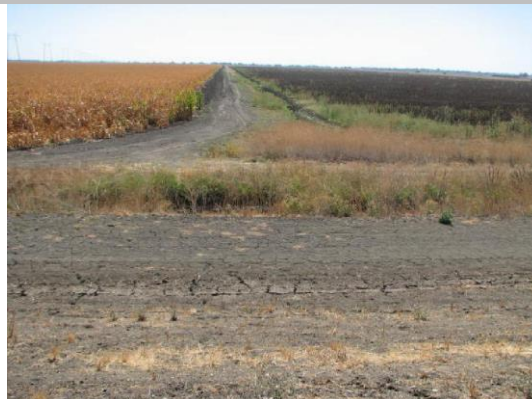
Photo 1 of 3 : UCIP_SP_2020_45302_22849.jpg

Landside view-overview

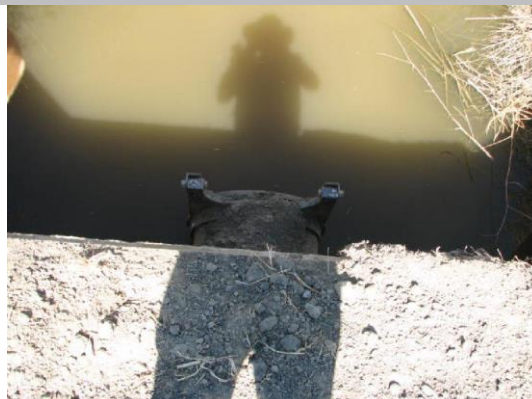
Photo 2 of 3 : UCIP_SP_2020_45302_22848.jpg

Waterside view-pipe and flap gate

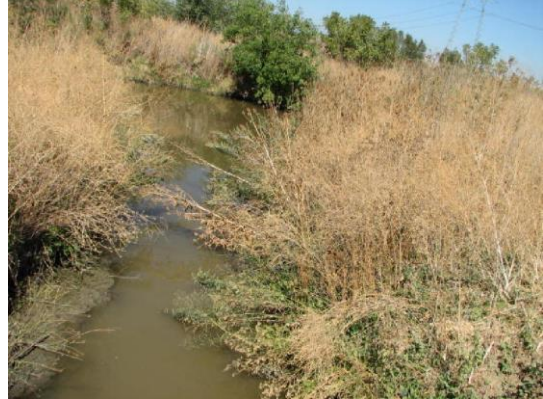
Photo 3 of 3 : UCIP_SP_2020_45302_22847.jpg

Waterside view- overview

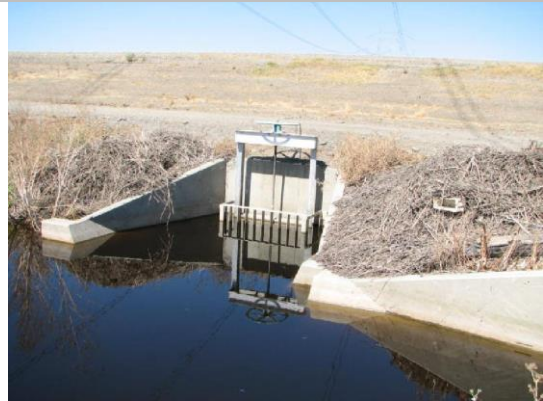
Photo 1 of 3 : UCIP_SP_2020_54251_22858.jpg

Landside view- inlet structure.

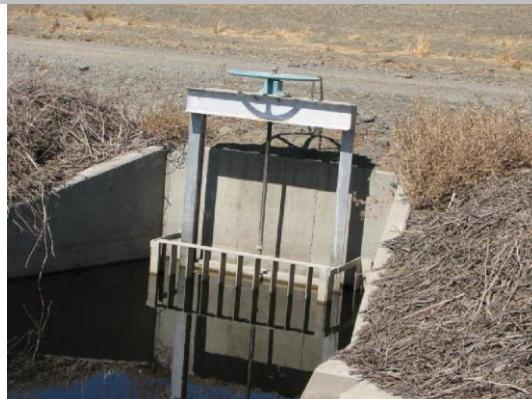
Photo 2 of 3 : UCIP_SP_2020_54251_22857.jpg

Landside view- trash rack and slide gate in inlet structure.

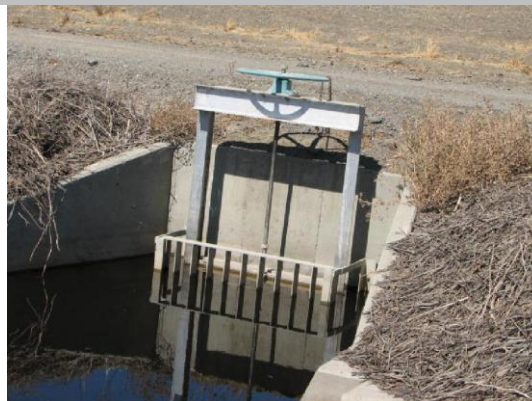
Photo 3 of 3 : UCIP_SP_2020_54251_22856.jpg

Landside view- Headwall with wing walls.

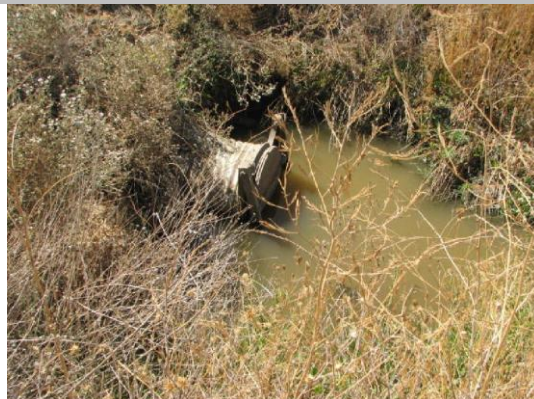
Photo 2 of 3 : UCIP_SP_2020_45306_22872.jpg

Waterside view- pipe and flap gate.

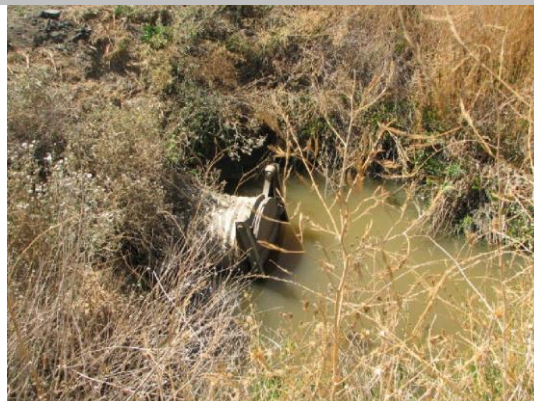
Photo 3 of 3 : UCIP_SP_2020_45306_22876.jpg

Waterside view- pipe and flap gate.

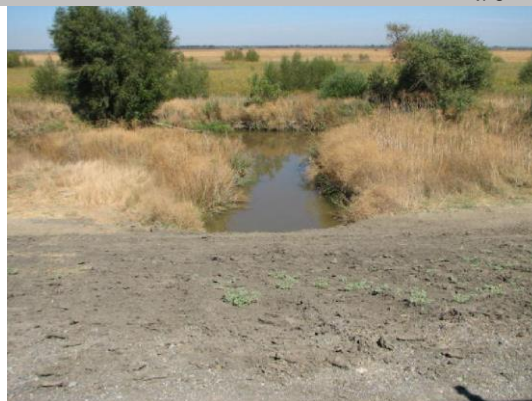
Photo 1 of 3 : UCIP_SP_2020_45307_22869.jpg

Waterside view- overview

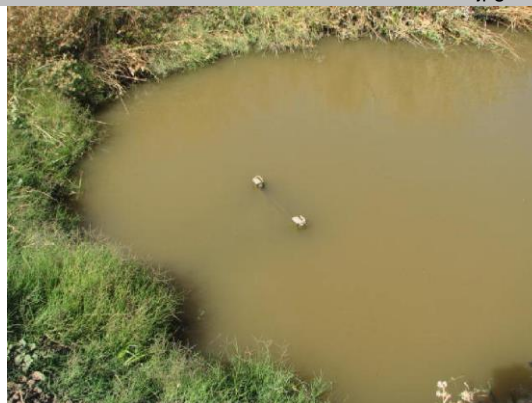
Photo 2 of 3 : UCIP_SP_2020_45307_22868.jpg

Waterside view- outlet structure under the water.

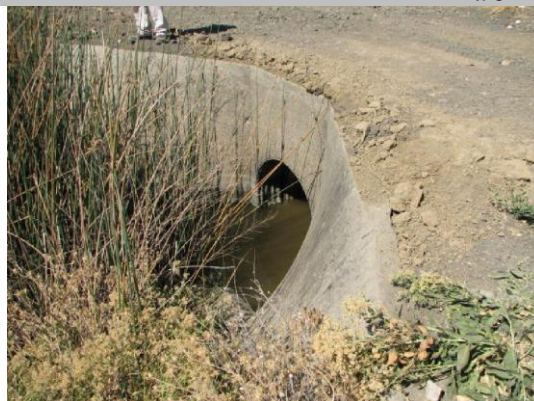
Photo 1 of 2 : UCIP_SP_2020_45309_22878.jpg

Landside view- Wing wall and pipe

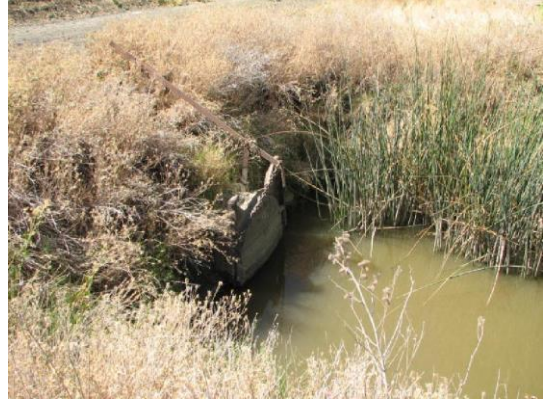
Photo 2 of 2 : UCIP_SP_2020_45309_22877.jpg

Waterside view- pipe and flap gate
